LHC Run 1: qu'est ce qui c'est bien passé, qu'est ce qui c'est mal passé et leçons pour le futur

V. Baglin pour le groupe TE-VSC

CERN TE-VSC, Geneva

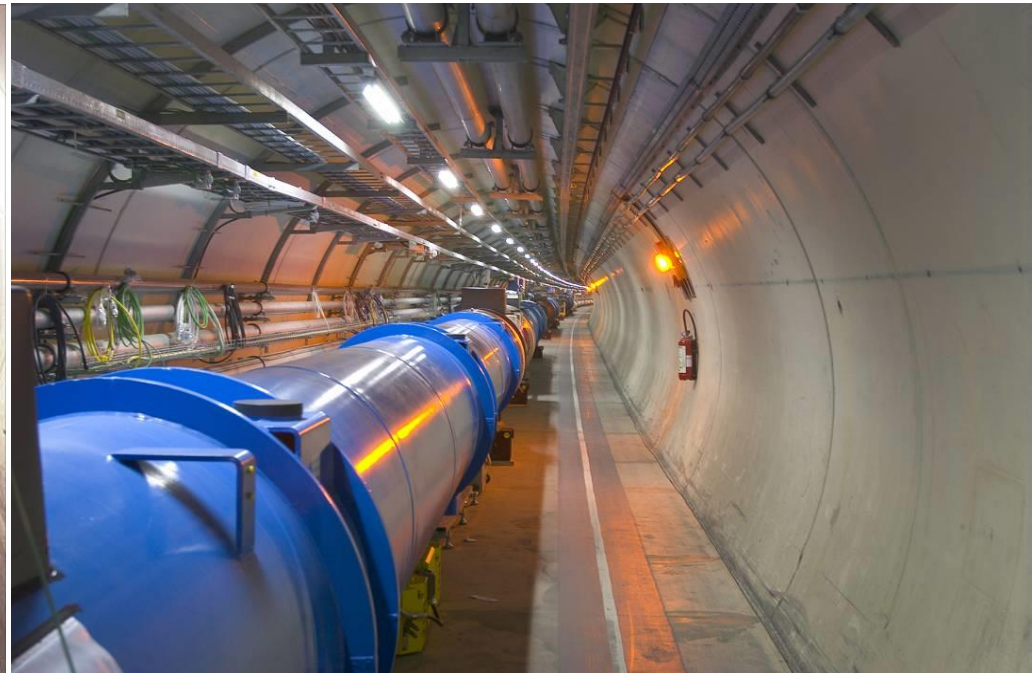
LHC Dipole Vacuum System

- Cryogenic vacuum system inside the arc
- A beam screen is housed inside the cold bore held at 1.9 K

- Cold bore (CB) at 1.9 K which ensures leak tightness
- Beam screen (BS) at 5-20 K which intercepts thermal loads and acts as a screen

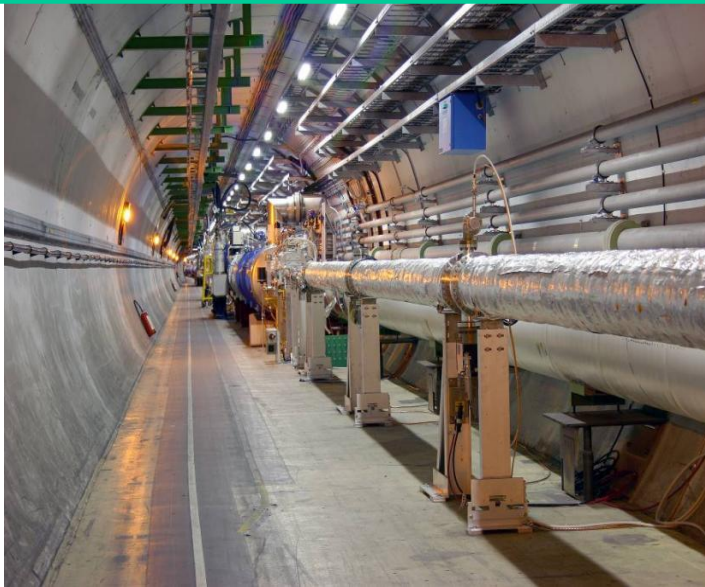
“Combined” sector in both side of each experiment

Both beams circulates in the same beam pipe

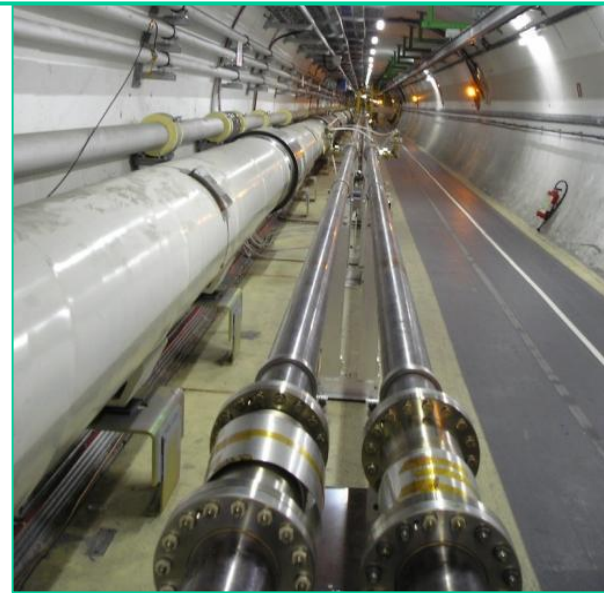
“Twin” sector

Beams circulate in different beam pipes

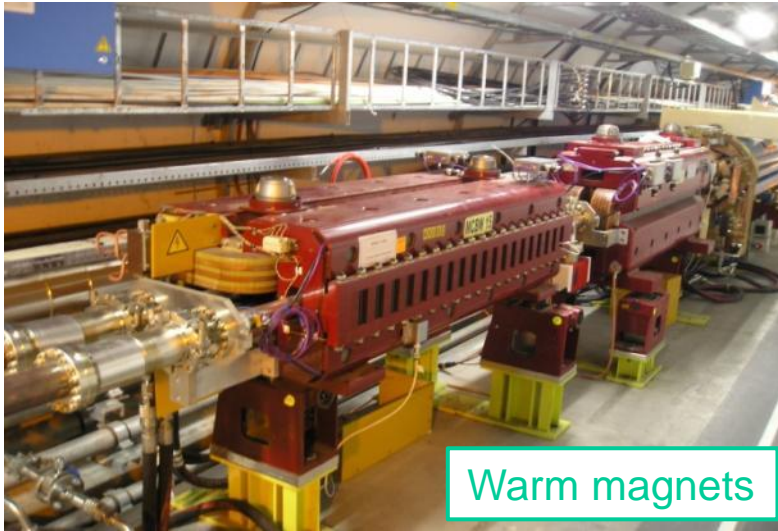
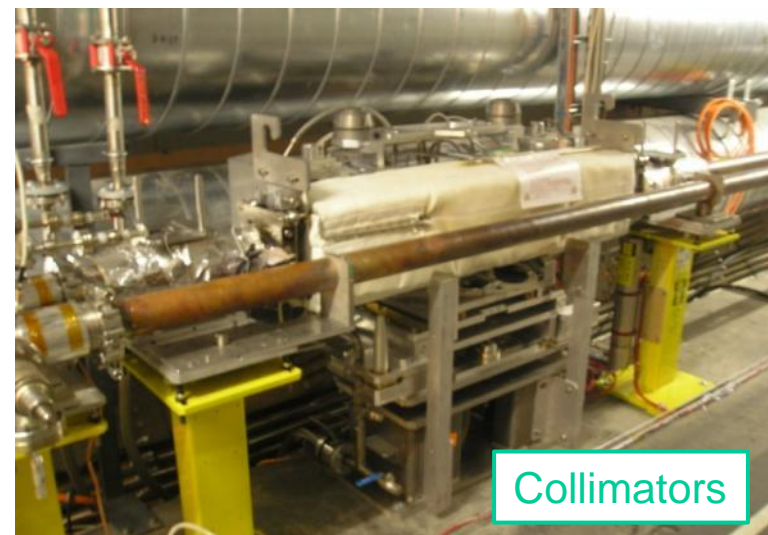
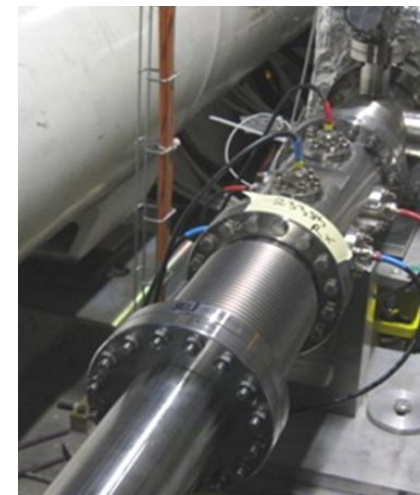
Standard Components Installed Inside LSS

- Warm magnets, kickers, septum, collimators, beam instrumentation ...

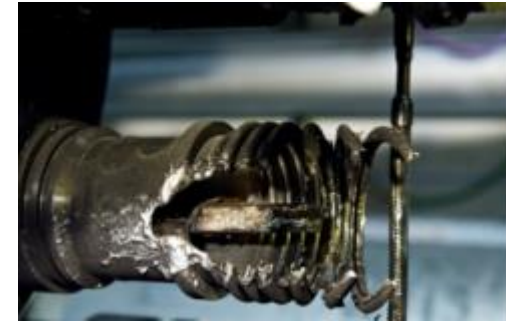
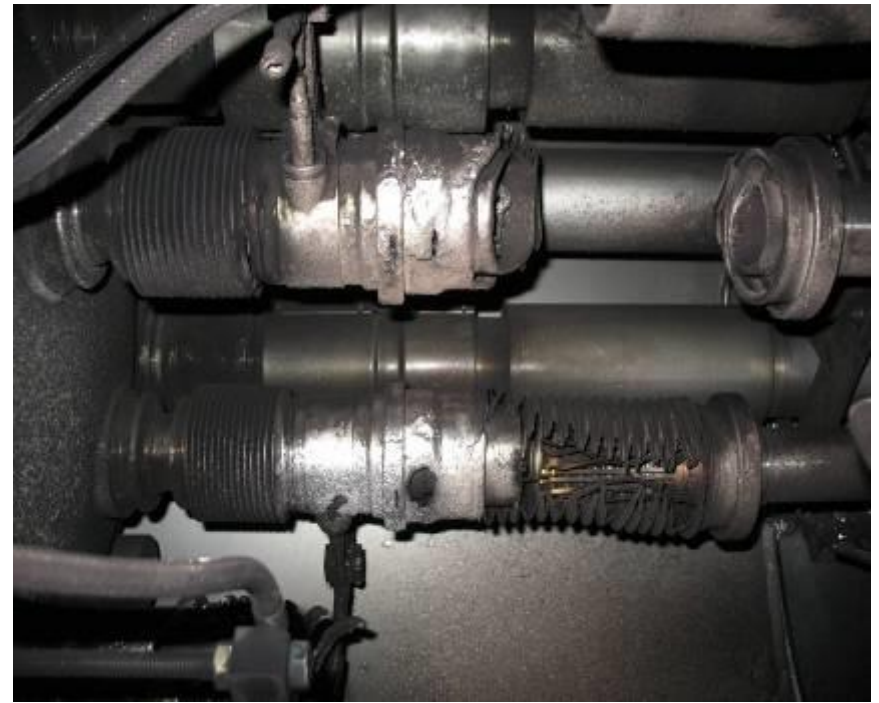
The Sector 3-4 incident (just before the 1st ramp)

Electrical arc at 8.7 kA in the interconnection
Rupture of bellows, expansion of liquid Helium with
superinsulation debris

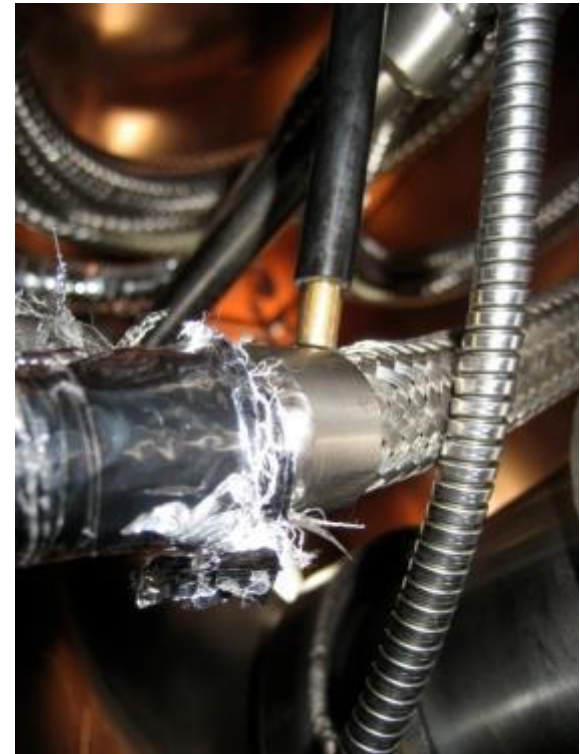
- A He leak of ~ 0.3 mbar.l/s appeared in insulation vacuum sector VACSEC A7L4.M the 11th of July.
- This sector starts at Q7L3 and finishes at the vacuum barrier at Q11L3
- A partial warm up to 300 K of the arc was decided to repair the leak

Faulty cooling circuit
Located in distribution feedbox DFBA

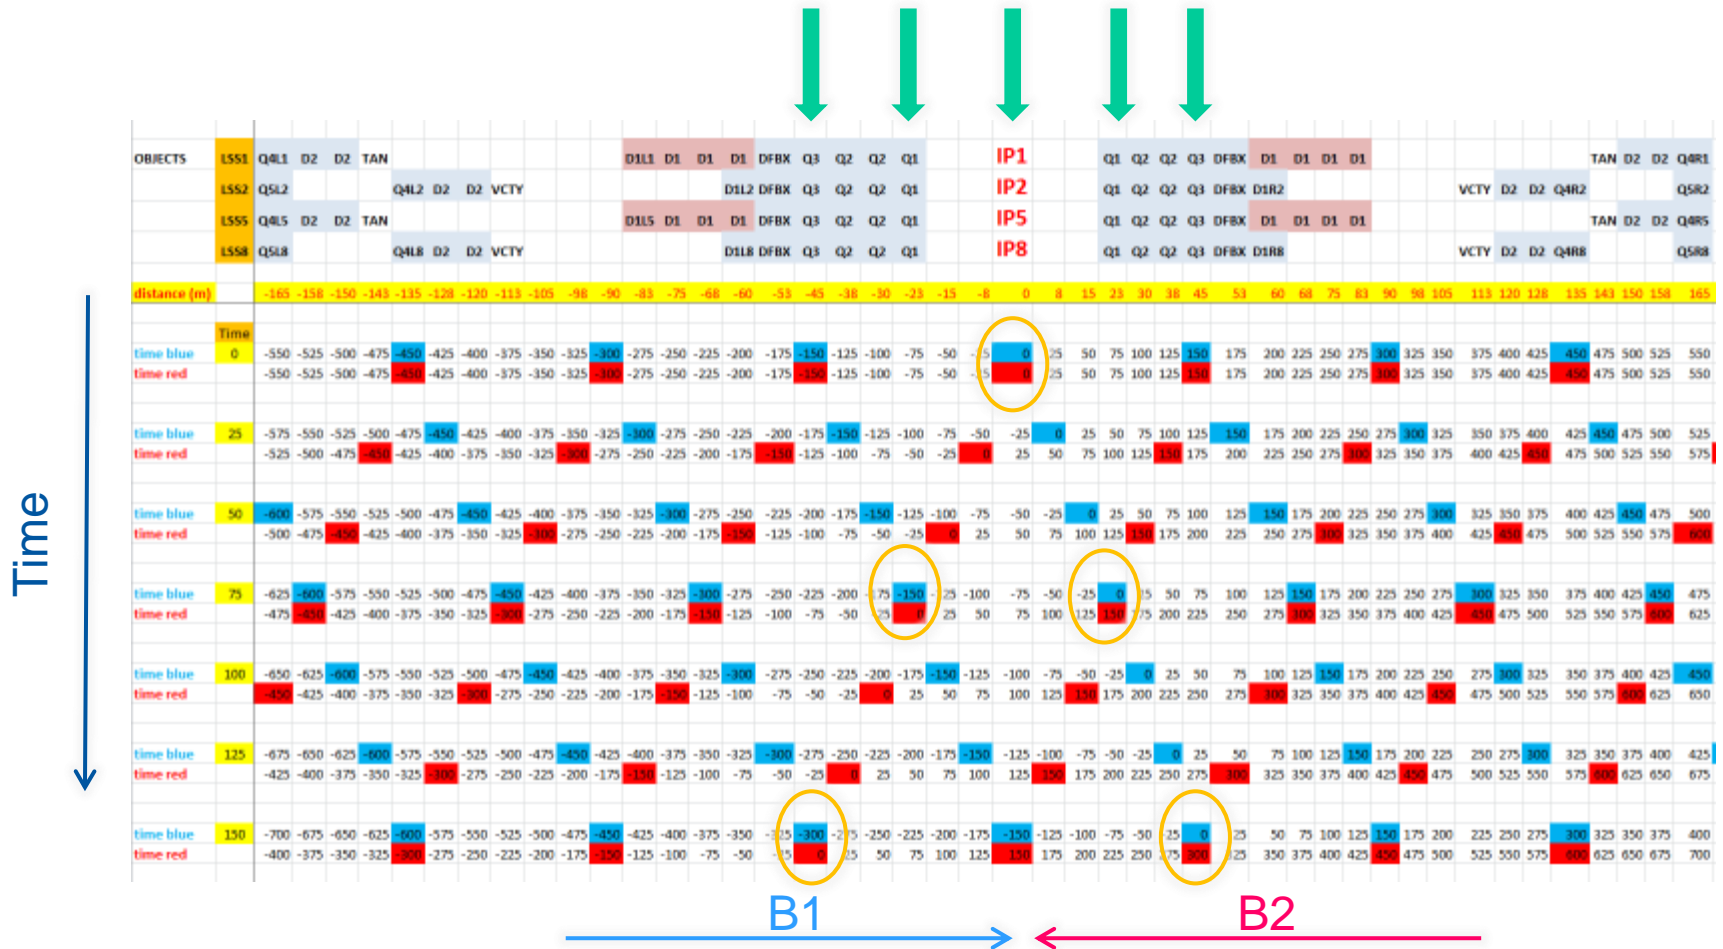
- Bunch spacing by 150 ns = 45 m
 - So the 2 opposite bunches which interacted at IP, will encounter again another bunch at multiples of $\frac{1}{2}$ bunch distance i.e. 22.5, 45, 67.5, 90 m etc.

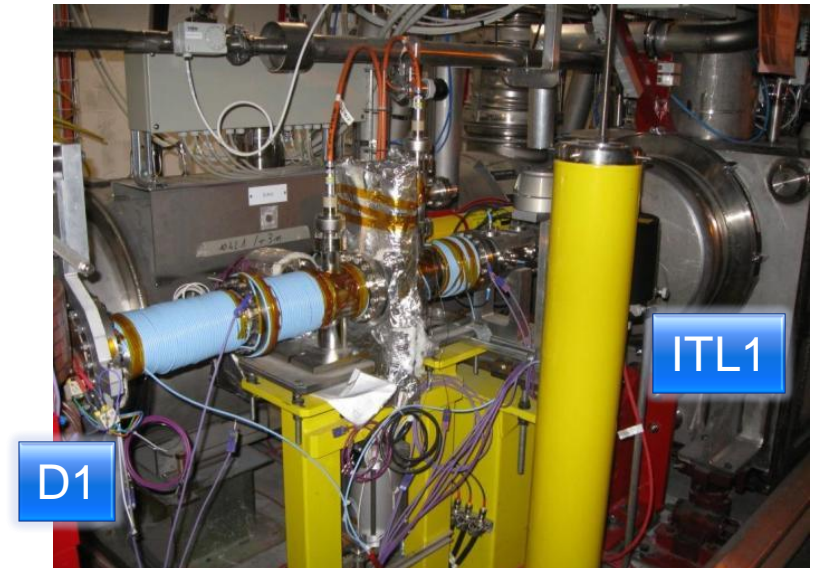
First Observation of Electron Cloud : 29-9-2010

- The position at 45 m from the IP is the **longest unbaked area** (operating at RT) in LHC, so the first candidate to trigger electron cloud

Magnetic field of solenoid \approx 20 Gauss

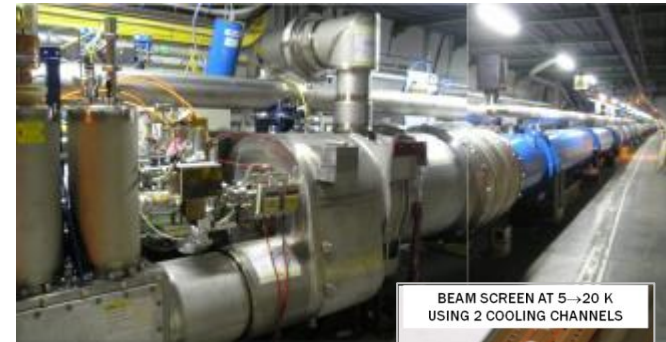
- 2 trends :
 - Room temperature
 - Cryogenic temperature

- Inside the arc, at 5-20 K, $\Delta P < 10^{-10}$ mbar (i.e. **below detection limit**)
- The photodesorption yield at **cryogenic temperature** is estimated to be $< 10^{-4}$ molecules/photon

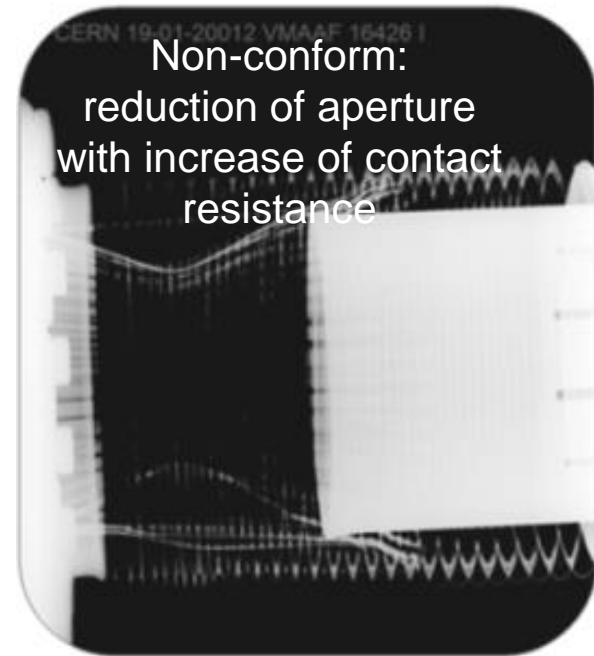
Fix of Non-Conformities during LS1 (2013-14)

- As a consequence of the 2 previous observations, a **systematic X-ray** analysis of all the vacuum modules was done: 1800 X-rays were taken during 2 years.
- The **repair** of 96 non-conform vacuum modules (~ 5% of total) is needed to **restore machine impedance** and to avoid pressure spikes/excursion
- 52 RT vacuum sectors impacted out of which 29 are opened during LS1 **on purpose** (~ 200 kCHF manpower)

Courtesy A. Vidal, J-M. Dalin EN-MME

- **LESSON** : 1) Write down and execute properly the **installation procedures with activity reports**
2) Implement a **quality assurance team**

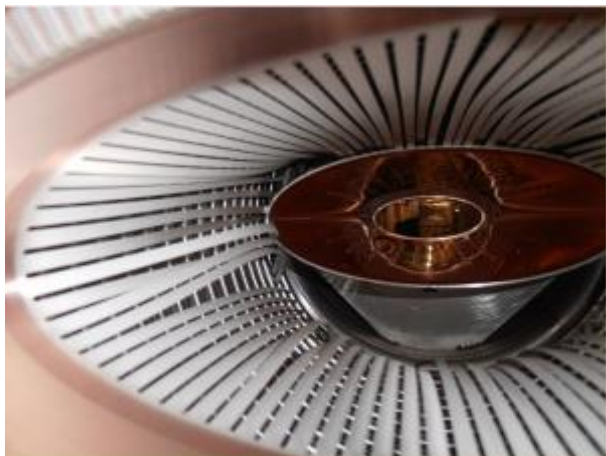
- Permanently deformed fingers
- Spring brazed to the finger

- Origin of the systematic default was identified to be due to a **poor contact** between the RF finger and the transition tube. The RF fingers were stiffened for 2012 consolidation.

- For LS1, the layout was **modified** to remove the badly design module
- **LESSON** : **always mechanically validate the design of components (even under schedule pressure)**

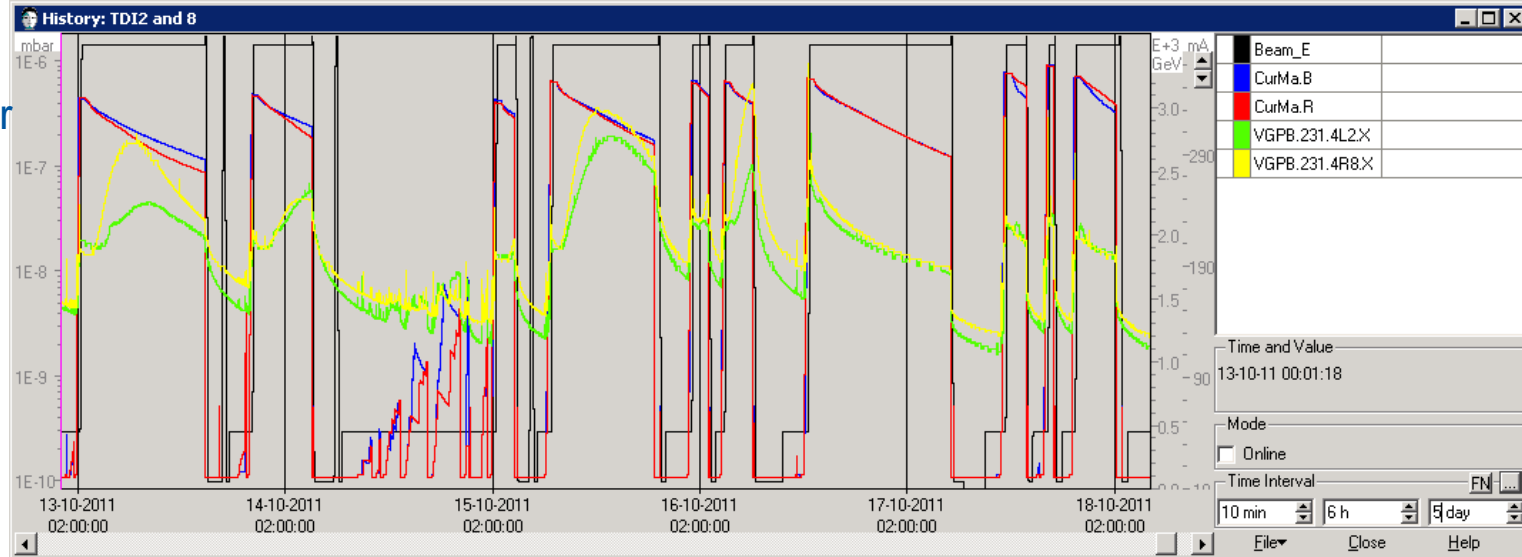
TDI in LSS2 and 8

- A movable mask to protect ALICE during injection (Boron nitride jaw)
- Deformed beam screen observed during winter technical stop 2011-12

- Beam induced **thermal outgassing**

- $\sim 10^{-7}$ mbar

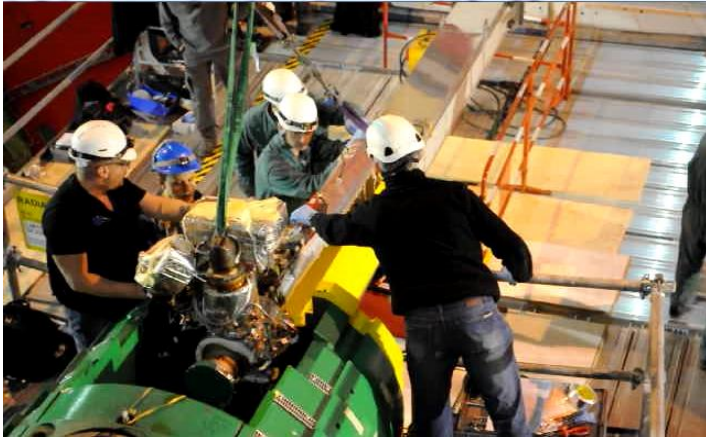
- The vacuum system was **over pressurised** to + 200 mbar to minimised air backstreaming into the NEG chambers
- The CMS forward **vacuum chamber** was **opened** and moved away for inspection

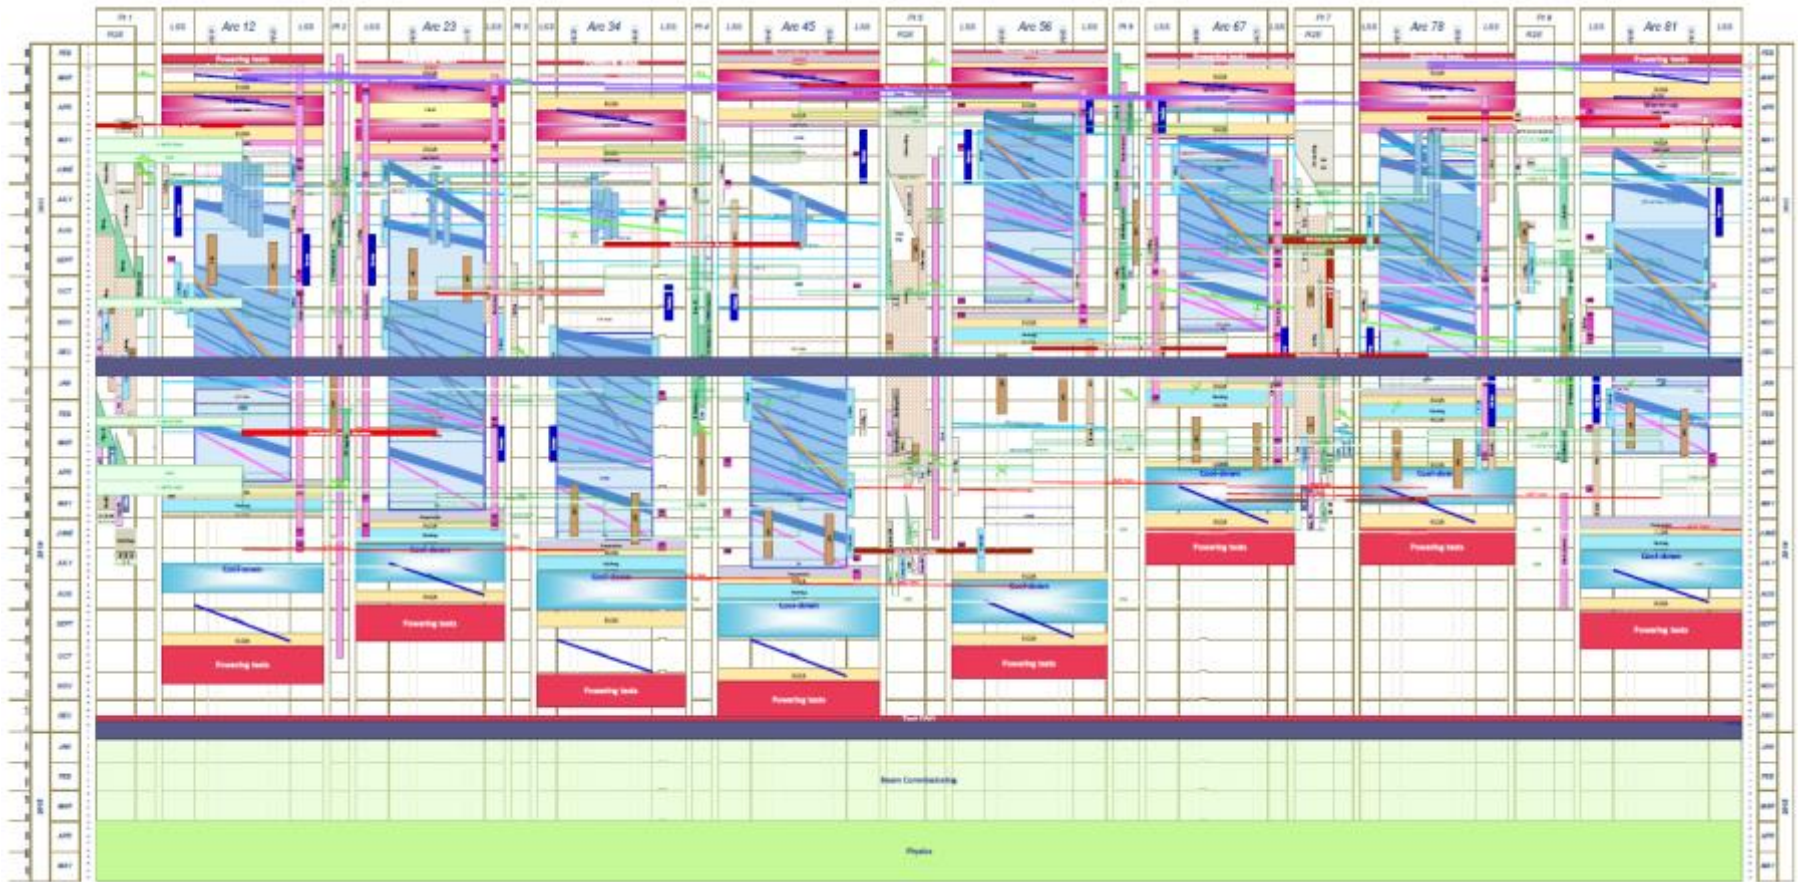
Long Shutdown 1 (LS1)

- Main aim : **consolidate the splice interconnection** between superconducting magnets to allow operation at 7 TeV/beam
- Started Feb 2013, Physics will resume April 2015
